Earthquake Contingency Plan for Ward 6, Rangamati Municipality: Volume 2

BUET-Japan Institute of Disaster Prevention and Urban Safety (BUET-JIDPUS)
Department of Urban and Regional Planning
Department of Civil Engineering
Bangladesh University of Engineering and Technology (BUET),
Dhaka-1000, Bangladesh.

**Earthquake Risk Assessment for Developing Contingency
Plans, Training Modules and Awareness Materials for
Rangpur City Corporation and
Tangail, Rangamati and Sunamganj Pourashavas**

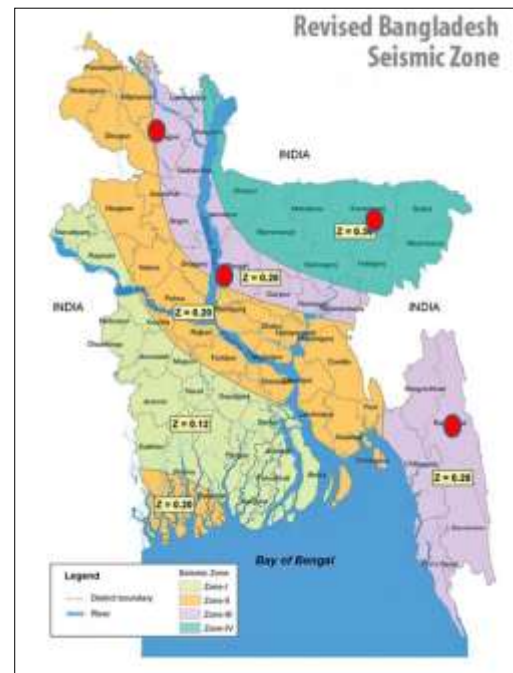
Figure 1.2: Revised Seismic Zoning of Bangladesh

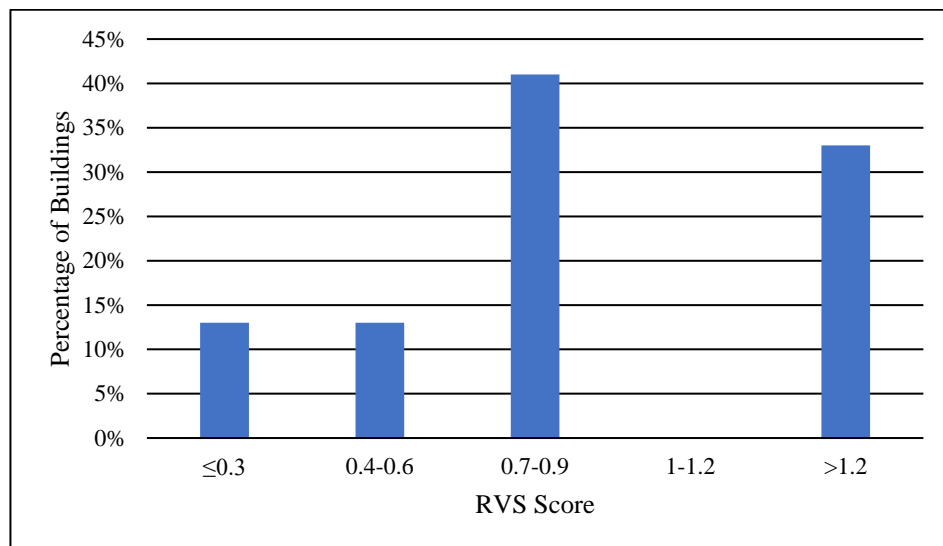
Figure 4.1 (a): Relations between percentage of buildings and RVS score of Ward 6 for moderately high seismicity

and Unreinforced Masonry building (URM). The maximum achievable score for these four types of buildings are 4.1, 2.1 1.4 and 1.2 respectively (as per FEMA requirements). However, as we consider the irregularities and soil class (D) the scores decline. So, an URM type building cannot receive a score greater than 1.2 in any circumstances. If a cut off score greater than 1.2 is set, it will not represent the true state of vulnerable buildings. Thus, a cutoff score of 1.2 has been selected. It has been observed that for the general case, the final score of 67% of the total surveyed buildings in ward 6 were below cutoff (1.2) and thus these are vulnerable. Table 4.1 presents the percentage of vulnerable buildings in each cluster.

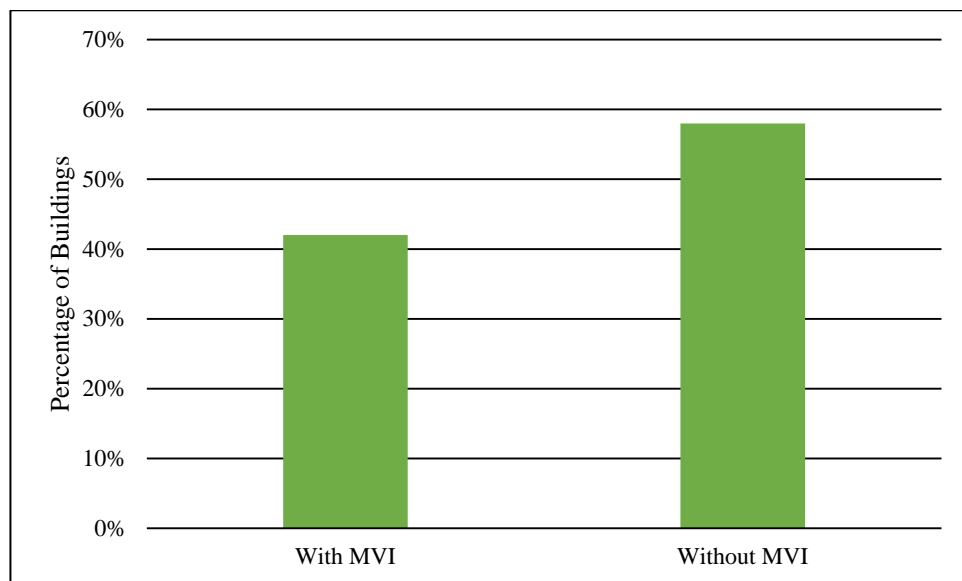
Figure 4.5 represents the relation between percentage of buildings and moderate vertical irregularity (e.g. in plane setback, sloping site, split level). It is found that 42% of the buildings have moderate vertical irregularity.

Figure 4.5: Relations between percentage of buildings and moderate vertical irregularity

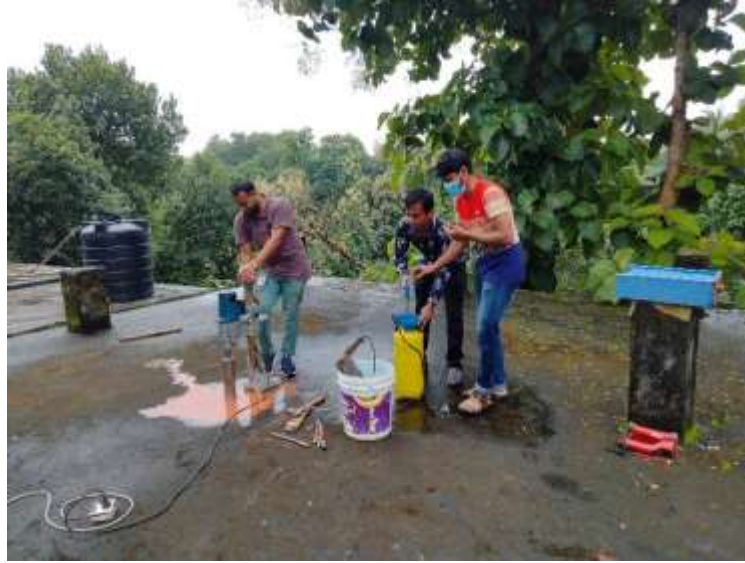
Strength of the concrete in the existing beams, columns and slabs has been assessed by extracting concrete core samples. Figure 5.1 shows the extraction of core from a slab. Location of core cutting and their respective strength has been provided in Appendix C. Variations have been observed in the concrete strength derived from tests of the core samples. This may have resulted due to the quality control issue and other uncertainties associated with the core collection and testing (Ahsan et al., 2018). Hence, by applying judgment, concrete strength has judiciously been considered between the lowest and mean value. From these results, concrete compressive strength of 1.2 ksi for slab, column and beam of the building has been used for the structural analysis on finite element software.

Figure 5.1: Core extraction from roof slab

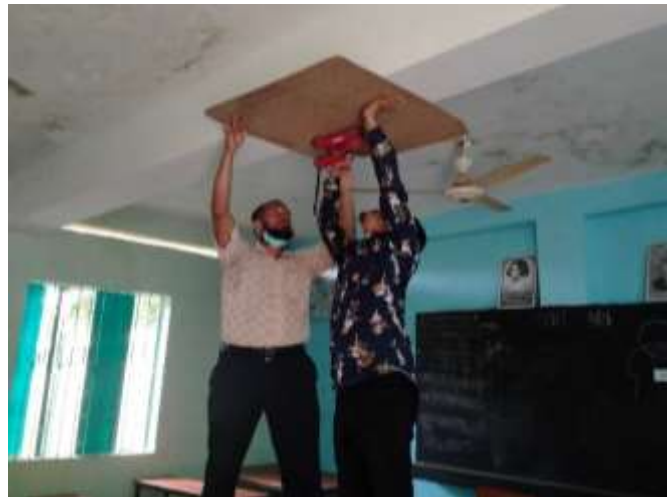
Ferro-scan tests of the building have been done to know the number and size of reinforcement in column, slab and beam. All scanned images of reinforcement layout are attached in Appendix C. Figure 5.2 shows ferro-scanning of a beam.

Figure 5.2: Ferro-scanning of a beam

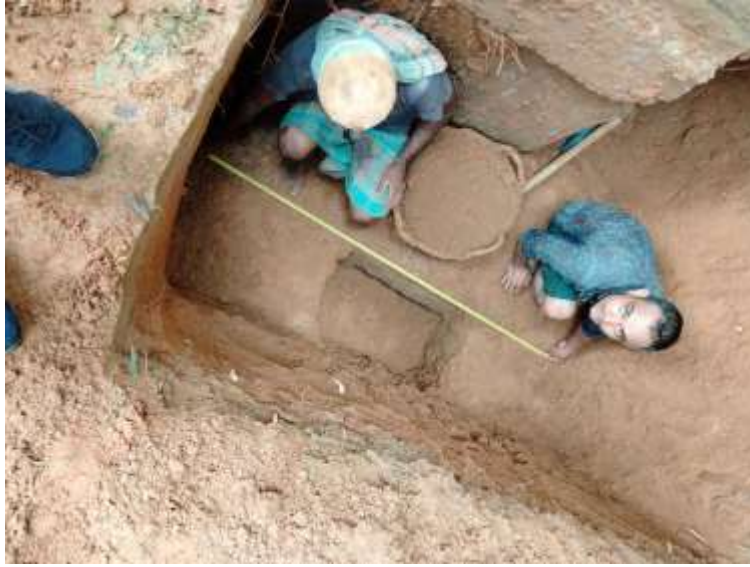
Foundations of the building were checked by excavating the soil. The size, thickness and depth were measured. Figure 5.3 shows the excavation of footing. Footing details have been attached in Appendix C.

Figure 5.3: Footing excavation

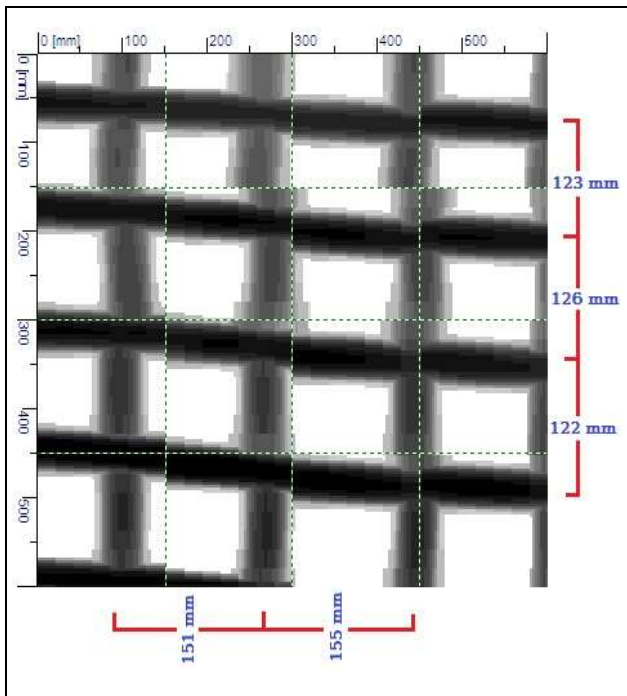
Figure E-42: Image scan of slab GF-S1
